Prosthetic Rehabilitation of Endodontically Treated Tooth by Using CAD-CAM Milled Zirconia Post and Core System: A Clinical Report

Keywords: CAD/CAM, Esthetics, Post & Core.

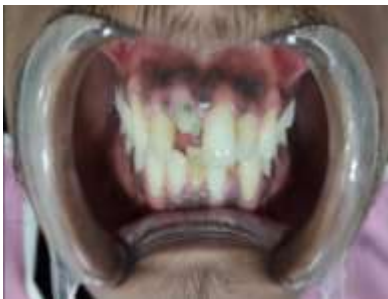
Fig 01: Pre - Treatment

A 23 years old male reported to Department of Prosthodontics, GDC Bengaluru with a complaint of fractured anterior teeth. (Fig

01) Patient desired his smile to be enhanced with replacement of fractured tooth segment with aesthetically pleasing appearance. Intra-oral examination revealed no abnormalities with acceptable oral hygiene. Based on the patient's esthetic requirements, considerations of remaining coronal tooth structure and occlusion, various treatment options were explained to patient, and the decision of restoring the tooth with CAD-CAM fabricated fibre post and core followed by full coverage Zirconia crown was made. Informed consent of the patient was obtained regarding the nature of the procedure, number of visits, total cost of treatment and possible consequences and risks had been explained to the patient. Informed consent was obtained from patient regarding photographs and documentation.⁴ Preliminary impressions were made using alginate for diagnostic cast. Patient education was made easier with this and treatment planning was made easier. Mock-up was made and final prosthesis can be visualized with the prepared mock up.

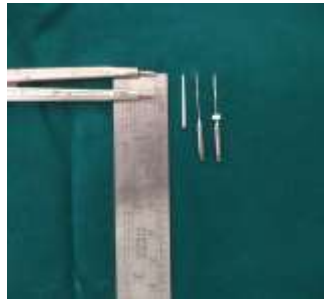
Fig 02: Instruments

Endodontic management was done wrt maxillary right central incisor, following with which the GP was removed for the placement of the fibre post with apical seal of remaining GP which is approximately 1/3rd of the root canal. GP was removed with peeso reamer considering the length and diameter of the canal.⁵ (Fig 02) After the cementation of the fibre post with resin cement, core build up was done with composite material of preferred shade to enhance the translucency of the crown. (Fig 03) Final impression was made with incorporation of gingival cord placed in the gingival crevice. After the impression, temporization (Fig 04) was done using zinc oxide eugenol cement. After the Zirconia crown was fabricated with CAD/CAM, it was assessed for shade with bisque trial (Fig 05) and finally cemented with 10-MDP containing resin cement.⁸ (Fig 06) Patient was given all the post cementation instructions and was recalled at the intervals of 1 week, 1 month and 3 months for follow up.

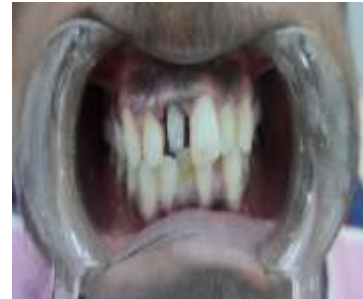
Fig 03: Core build-

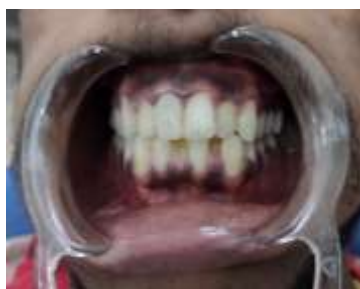
Fig 04: Temporization

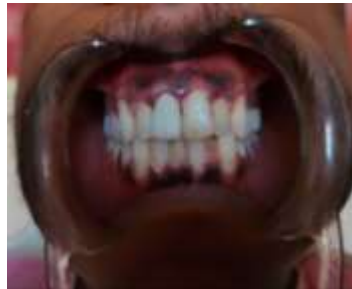
Fig 05: Bisque Trial

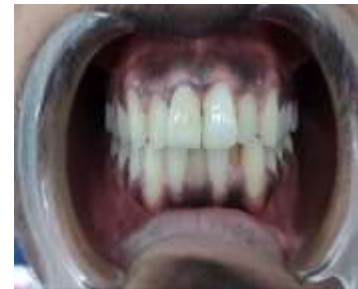
Fig 06: Post - Treatment
